Pinetops, N.C., Completes Sewer System Overhaul

By Dick Schantz

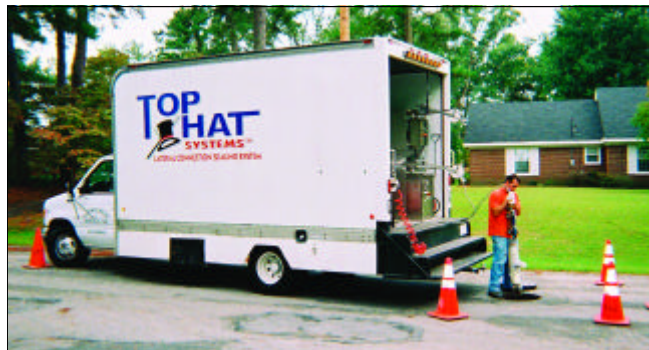
Southwest Pipeline and Trenchless Corp. Top Hat crew placing Top Hat applicator into manhole.

- Dig and replace about 100 laterals and/or main connections to the CIPP rehabilitated pipe that could not be repaired with trenchless techniques.
- Install 250 Top Hat lateral seals (1) sealing newly lined laterals to the CIPP relined pipe, (2) repairing truss pipe lateral Y connections and (3) repairing break-in taps at the sewer mains.

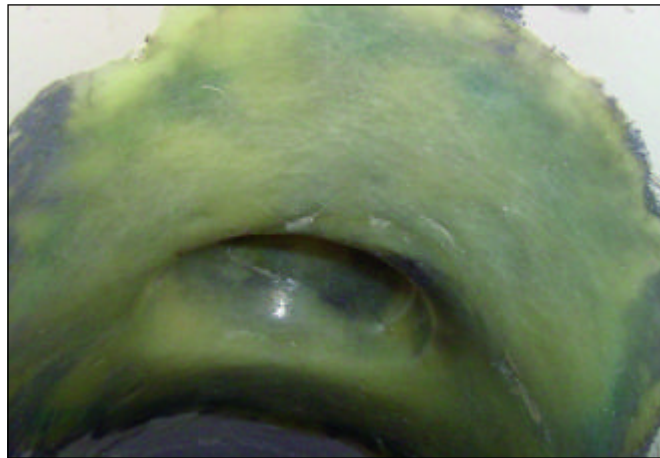
Typical installed Top Hat lateral seal.

Once the lateral liners were put in and the Top Hat lateral seals installed, a visible decline in infiltration was recorded at the treatment plant and this continued as more and more of the system was closed by sealing the laterals at the main connection with Top Hat. Engineers continue to confirm the groundwater around the CIPP liners and manholes rapidly seeks the easiest route it can find into the sewer system, thus all laterals and lateral to mainline connections below the water table had to be sealed if the 70 percent reduction was to be reached.
